DEPARTMENT OF TRANSPORTATION

Contract #: 04-0120F4Cty: SF/ALA Rte: 80 PM: 13.2/13.9File #: 69.28**WELDING INSPECTION REPORT****Resident Engineer:**Siegenthaler, Peter**Address:** 333 Burma Road**City:** Oakland, CA 94607**Report No:** WIR-022911**Date Inspected:** 22-Apr-2011**Project Name:** SAS Superstructure**OSM Arrival Time:** 700**Prime Contractor:** American Bridge/Fluor Enterprises, a JV**OSM Departure Time:** 1900**Contractor:** Zhenhua Port Machinery Company, Ltd (ZPMC), Changxing Island **Location:** Shanghai, China**CWI Name:** Gang Wei**CWI Present:** Yes No**Inspected CWI report:** Yes No N/A**Rod Oven in Use:** Yes No N/A**Electrode to specification:** Yes No N/A**Weld Procedures Followed:** Yes No N/A**Qualified Welders:** Yes No N/A**Verified Joint Fit-up:** Yes No N/A**Approved Drawings:** Yes No N/A**Approved WPS:** Yes No N/A**Delayed / Cancelled:** Yes No N/A**Bridge No:** 34-0006**Component:** OBG**Summary of Items Observed:**

TRIAL ASSEMBLY YARD

OBG 14EAST

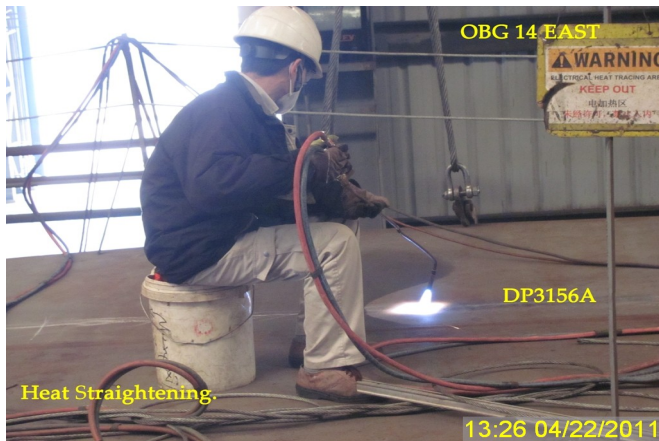
This Quality Assurance (QA) Inspector observed ZPMC personnel performing heat straightening, member identified as deck panel (DP3156A). Distortion appeared to be caused by welding. Weld number identified as SEG3019X-033. ZPMC Quality Control (QC) inspector identified as Mr. Zhu Yuan Yuan was present to monitor the heat straightening process. The heat straightening appeared to comply with heat straightening Report HSR1-10312.
